*Joint  
Highway  
Research  
Project*

IMPACT OF LEBANON BY-PASS 1950 TO 1963

Progress Report

Highway Impact Studies:

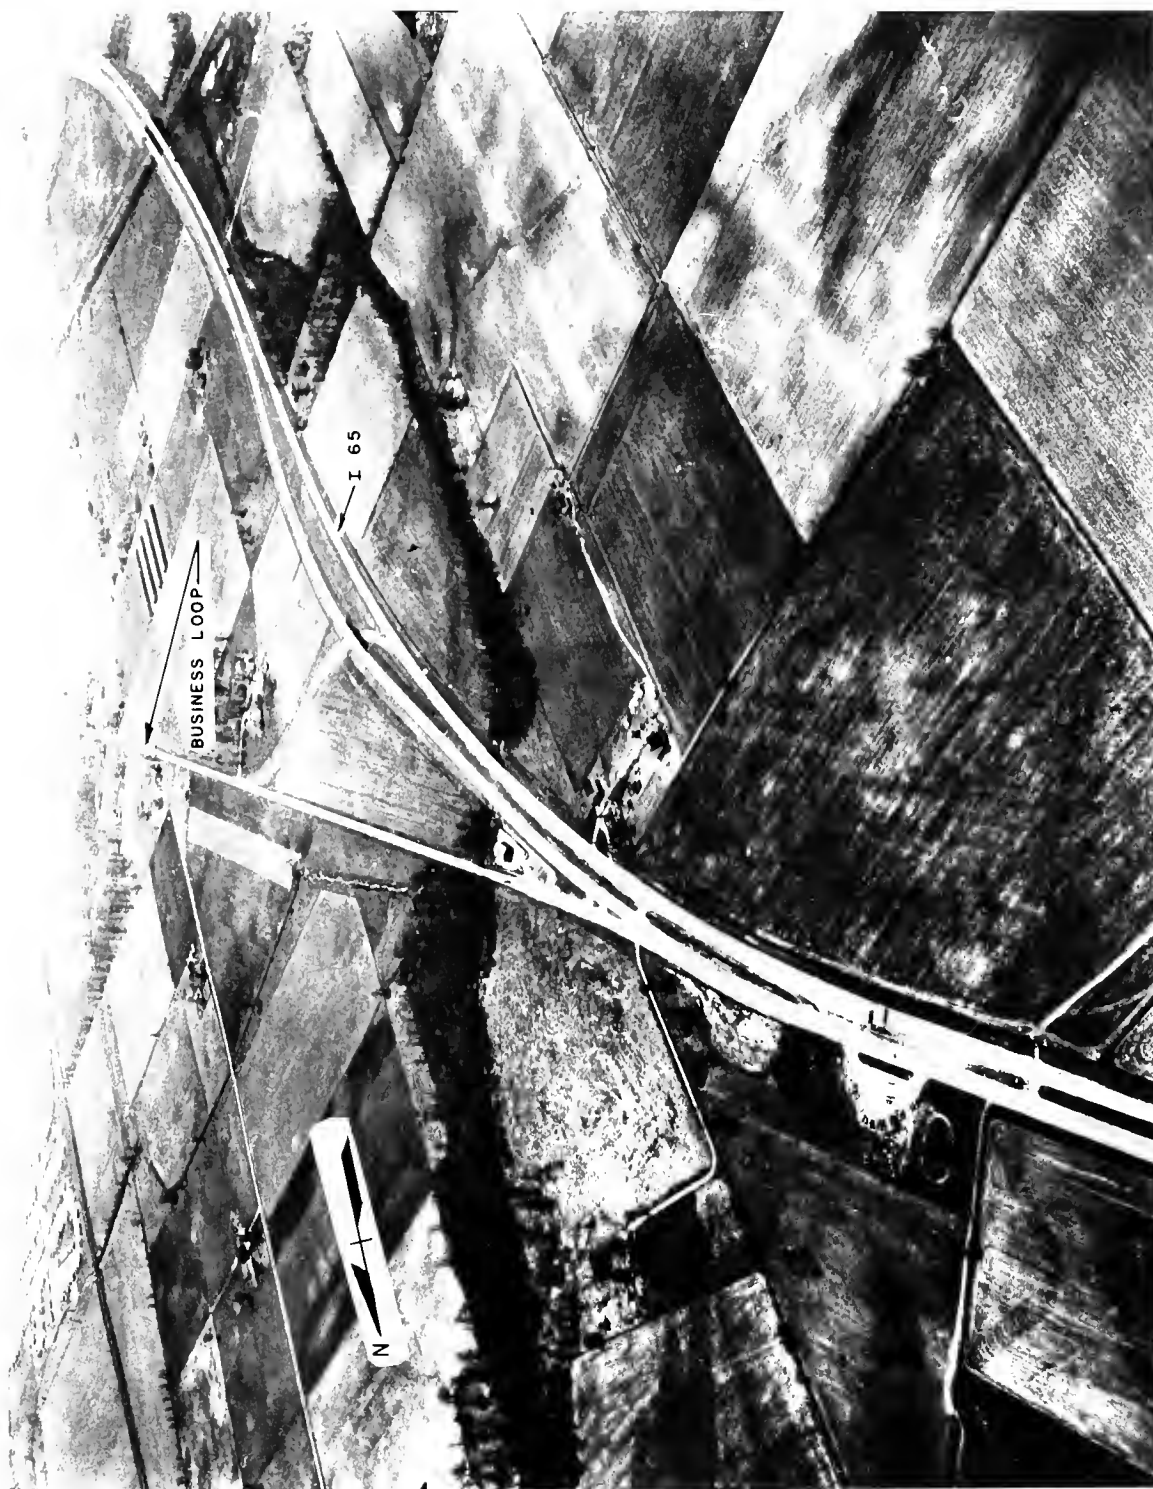
FIGURE 14

I 65-BUSINESS LOOP INTERCHANGE NORTHWEST OF LEBANON

PHOTO TAKEN APRIL 1963

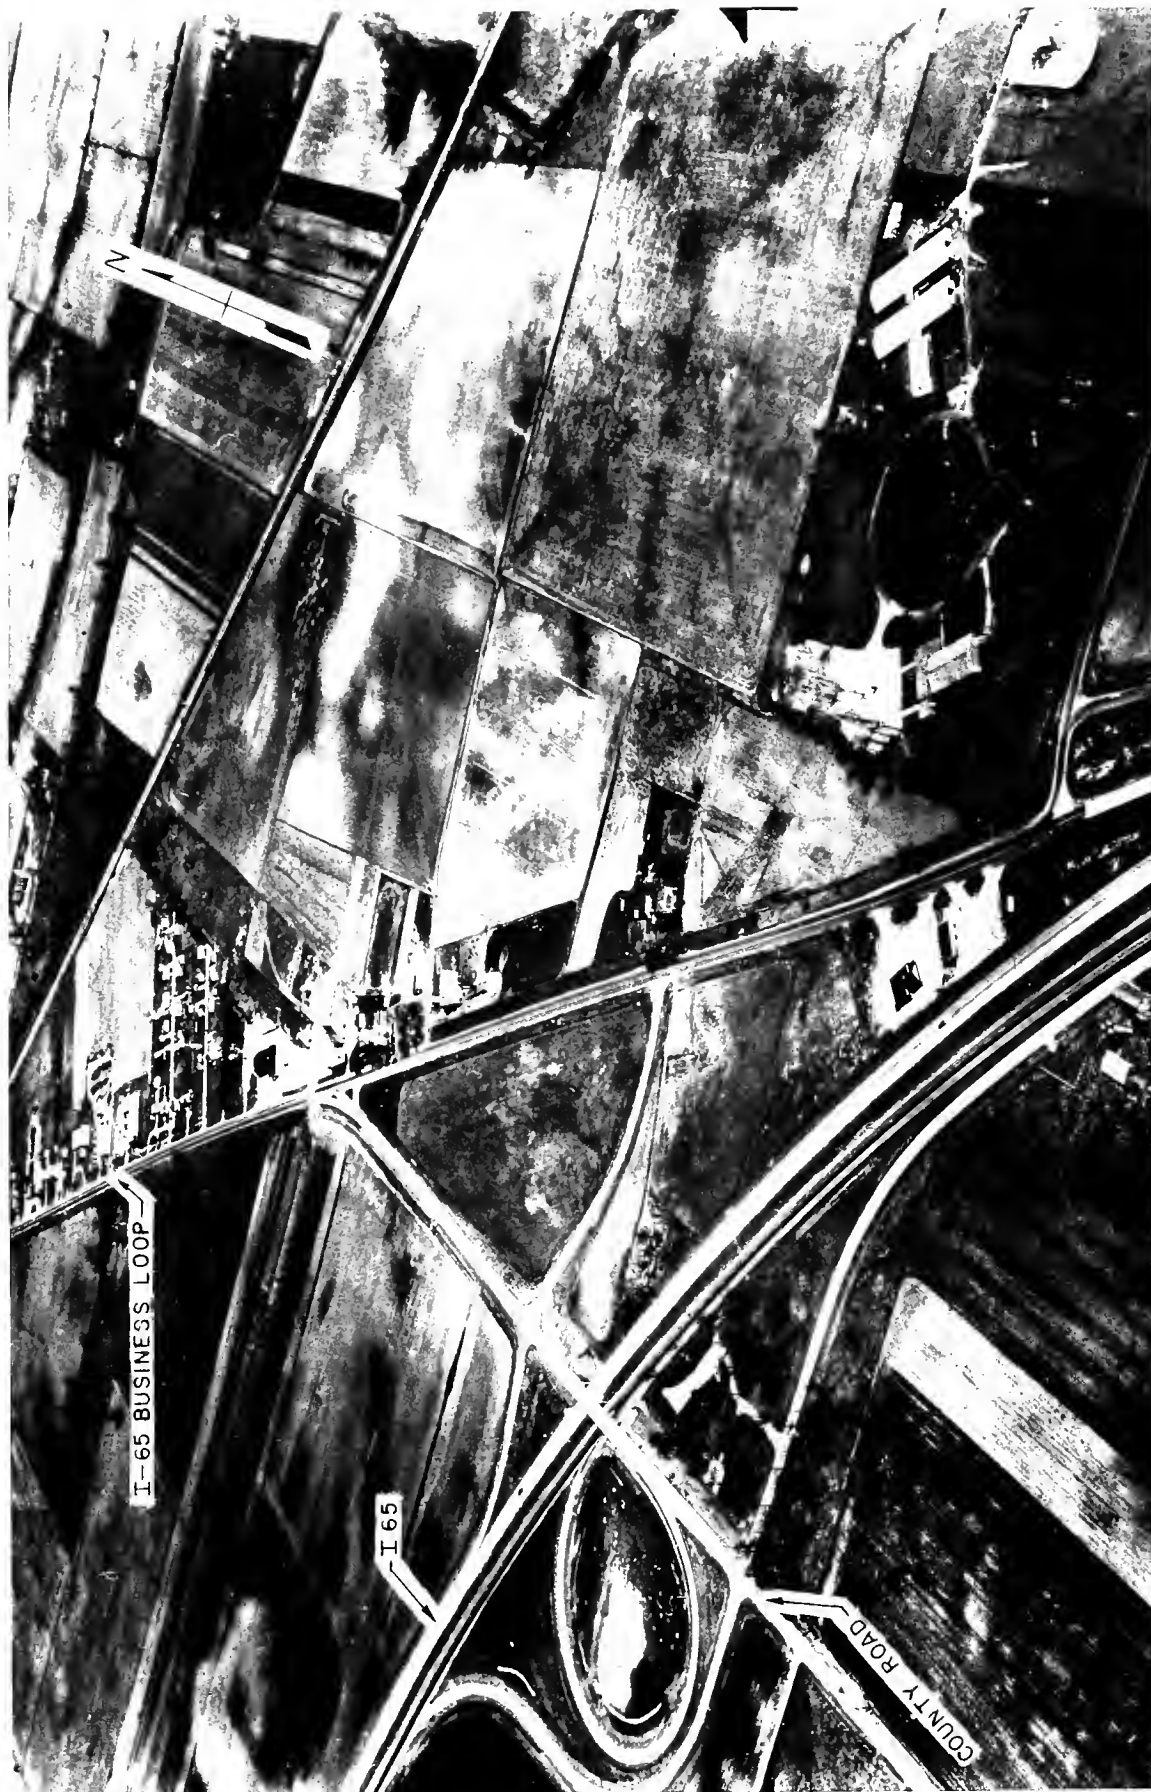
FIGURE 17

I-65 — BUSINESS LOOP INTERCHANGE SOUTH EAST OF LEBANON

PHOTO TAKEN APRIL 1963

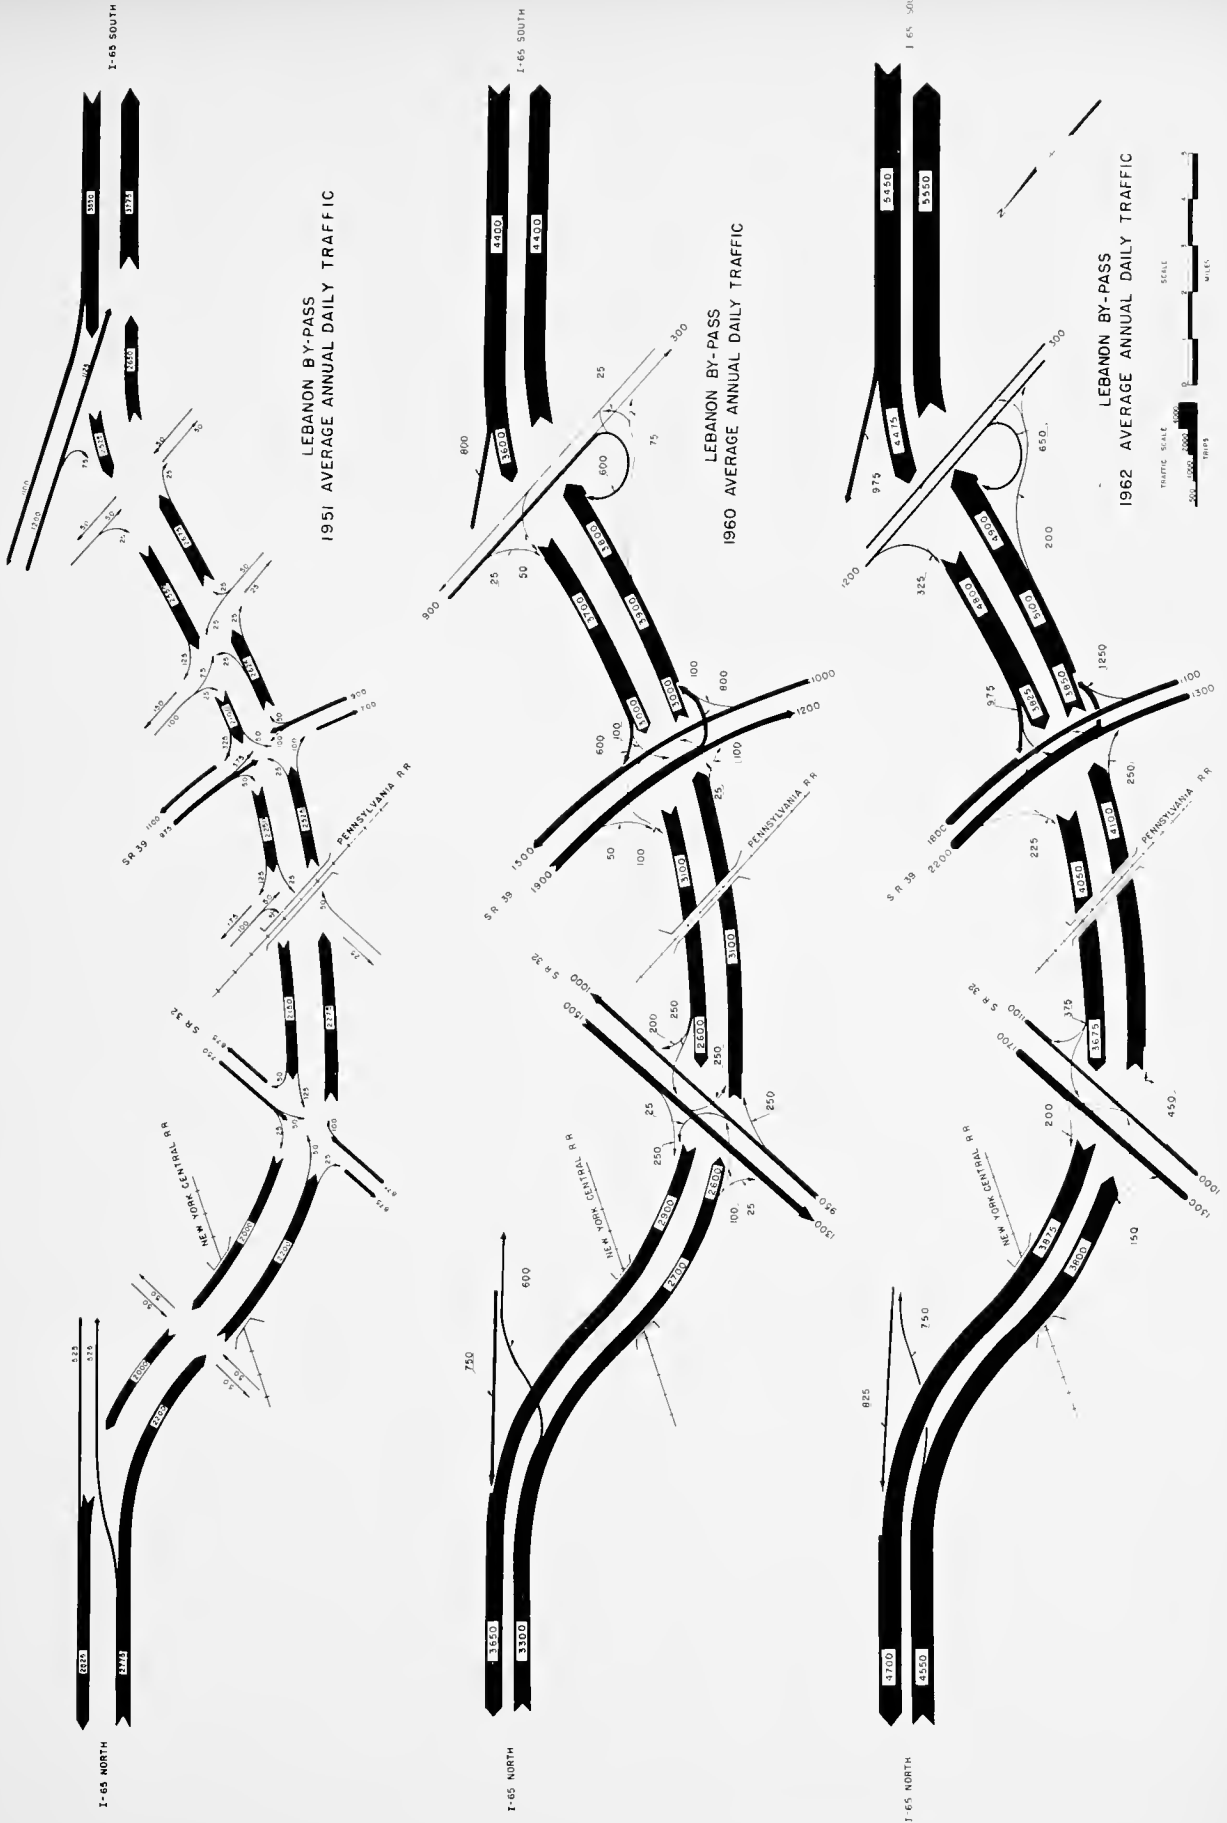
TRAFFIC VOLUMES ON LEBANON BY-PASS  
FIGURE 32

The decision to reconstruct the By-Pass as a part of I-65 resulted in the elimination of the congestion conditions that were affecting its usefulness. Access control eliminated eight at-grade intersections and replaced them with four interchanges. The resulting volume conditions indicate that a number of changes have occurred in the travel pattern (see Figure 32). The I-65 through traffic continues to use the By-Pass as shown in Figure 35. One of the noticeable changes, however, is that the SR 39 interchange has apparently replaced the city route of US 52 as the major south entrance to Lebanon. Entrance to the city on SR 39 might indicate that the drivers are missing the I-65 business loop exit, and thus use the next interchange. However, examination of the turning movements at the SR 39 interchange indicate that the majority of traffic using the ramps are either entering the city from I-65 northbound or leaving the city on I-65 southbound. The distribution of these turning movements would tend to indicate that local drivers prefer this interchange to the designated business loop. Further indication of this fact is that the volume on the business loop has decreased 30 percent since 1951 while the turning movements at SR 39 have increased almost 300 percent (see Figure 32).
